A Case Study on Moisture Problems and Building Defects

Nur Liyana Othman^{*}, Mastura Jaafar, Wan Mariah Wan Harun, Fuziah Ibrahim

School of Housing, Building and Planning, Universiti Sains Malaysia, Malaysia

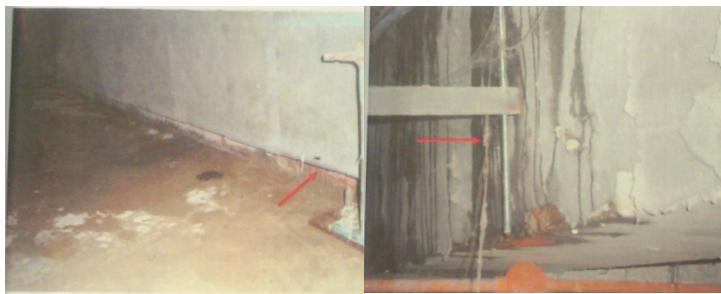
Most of problems arise due to poor workmanship. Ceiling leakage also caused by improper installation of waterproofing. Figure 2 shows the leakage problems came from AHU room which is located above the Operation Theatre room area. There are no waterproofing layers at the AHU room slab. Besides that, the improper plastering works at the AHU room wall had cause water seepage through the exterior wall then spread into the concrete slab and beam to the Operation Theatre room ceiling. The improper drainage such as scupper drain contributed to this matter. Result from this issue are stains of water marks, stalactite and stalagmite and mould growth at the Operation Theatre concrete ceiling. Indoor pollutants like this could contribute to: 1. failure of bacteria count test at the operation theatre and 2. the movement of the beam that supported the wall. The movement of this structural element could happen due to deterioration of the concrete and corroded steel reinforcement because of continuous in contact with water or aggressive chemicals over the years and will jeopardize the structures. The leakage problem also happened at many roof areas due to no inadequate gradient level and waterproofing failure will contribute to the water seepage through the wall then spread into the concrete slab and beam then to the ceiling.

Fig. 2. Leakages due to poor workmanship at AHU room above Operation Theatre (a) The improper wall plastering at AHU room, the water can enter through the wall (b) The leakages sign at the beam under the AHU room slab

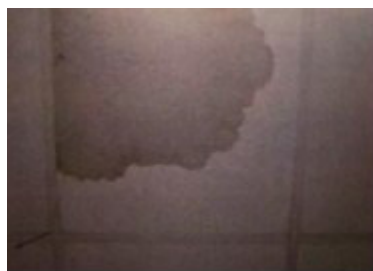
The next cause of defect is condensation. The issue of condensation affect the ceiling because the different temperature has created the water drop below the floor slab and above the ceiling. The issue of water drop above the ceiling also caused by no insulation layer on an outlet pipe, refrigerator pipe, ducting air conditioner and other type of pipe as shown in Figure 3 below. Thus, it creates the watermarks on the ceiling.

Fig. 3. Watermarks on ceiling due to water drop (condensation) from Exhaust Fan Ducting system at Pharmacy Store

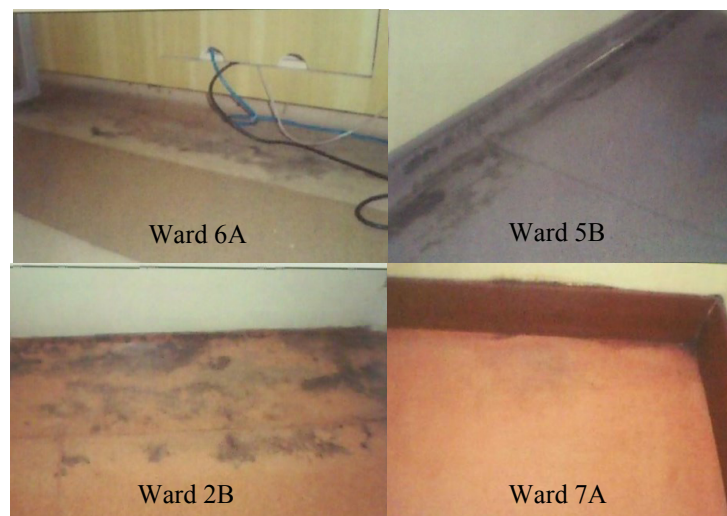
The moisture problem that happens on the floor is water seepage that is related to the improper waterproofing installation. The affected area is at vinyl and carpet floorings outside the toilet areas as shown in Figure 5 below. The water from the toilet area penetrated through the concrete slab. Based on inspection in year 2008, the areas that were affected from this leakage problem were medical area level 2 and Toilet, Corridor, Room 2B, Room 5-8, On Call Room (OCR) and Ward 2A at level 3. However within the next 4 years, the leakage problem has spread to the whole 7 Storey Ward Block. As a result, it creates building defects such as black staining and mould growth. If this problem is not resolve, it will rust the reinforcement bar and cause concrete spalling problem at the soffit slab.

Fig. 5. Black staining and dampness on floor finishes at 7 Storey Ward Block due to water seepage from toilet area
