## LECTURE 2

# Major defect types in flexible pavements

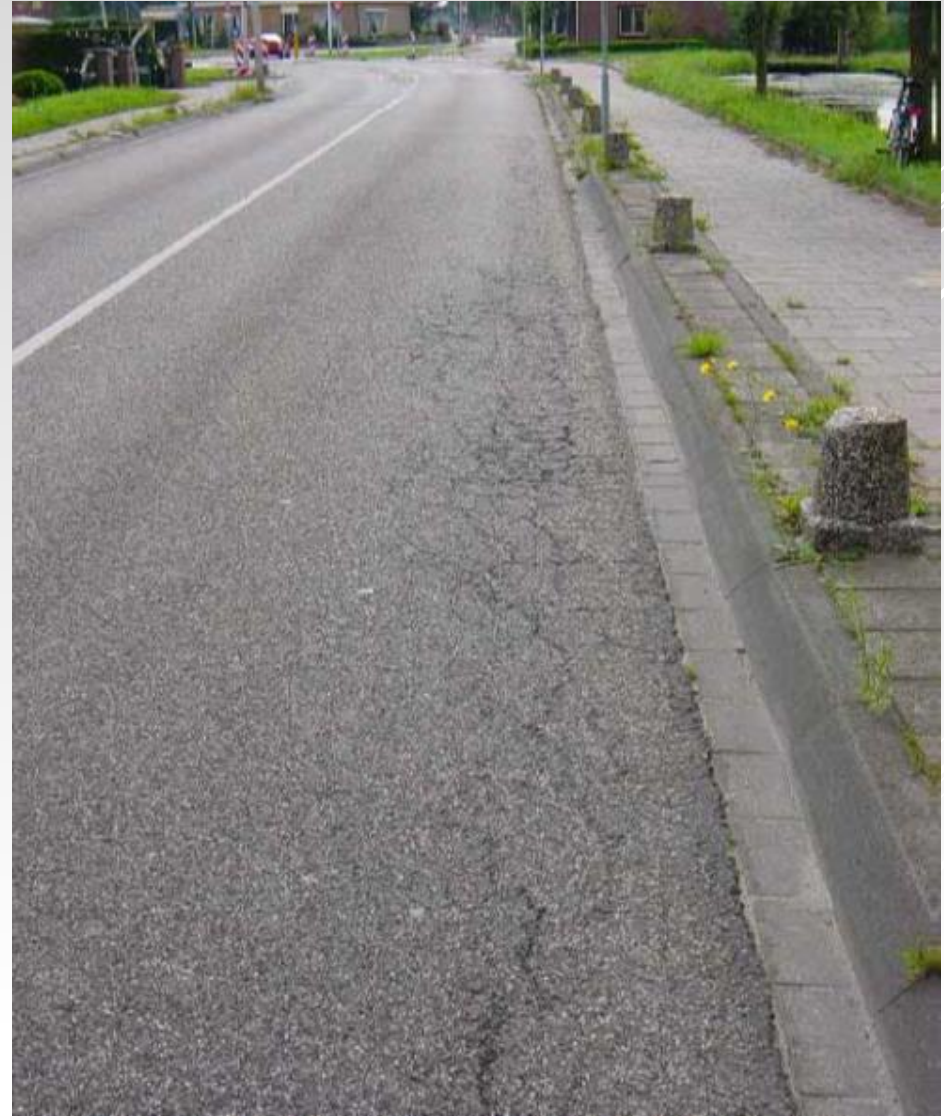
Cracks in pavements occur because of different reasons. They might be traffic load associated or might develop because of thermal movements or some other reason. Figure 2 e.g. shows a combination of wheel track alligator cracking and longitudinal cracking. These cracks are wheel load associated. Please note that the cracks only appear in the right hand wheel track close to the edge of the pavement. This is an indication that the cracks are most probably due to edge load conditions resulting in higher stresses in the wheel track near the pavement edge than those that occur in the wheel track close to the center line. Because of this specific loading condition, cracks might have been initiated at the top of the pavement.

*Figure 2: Longitudinal and alligator cracking in the Wheel path.*

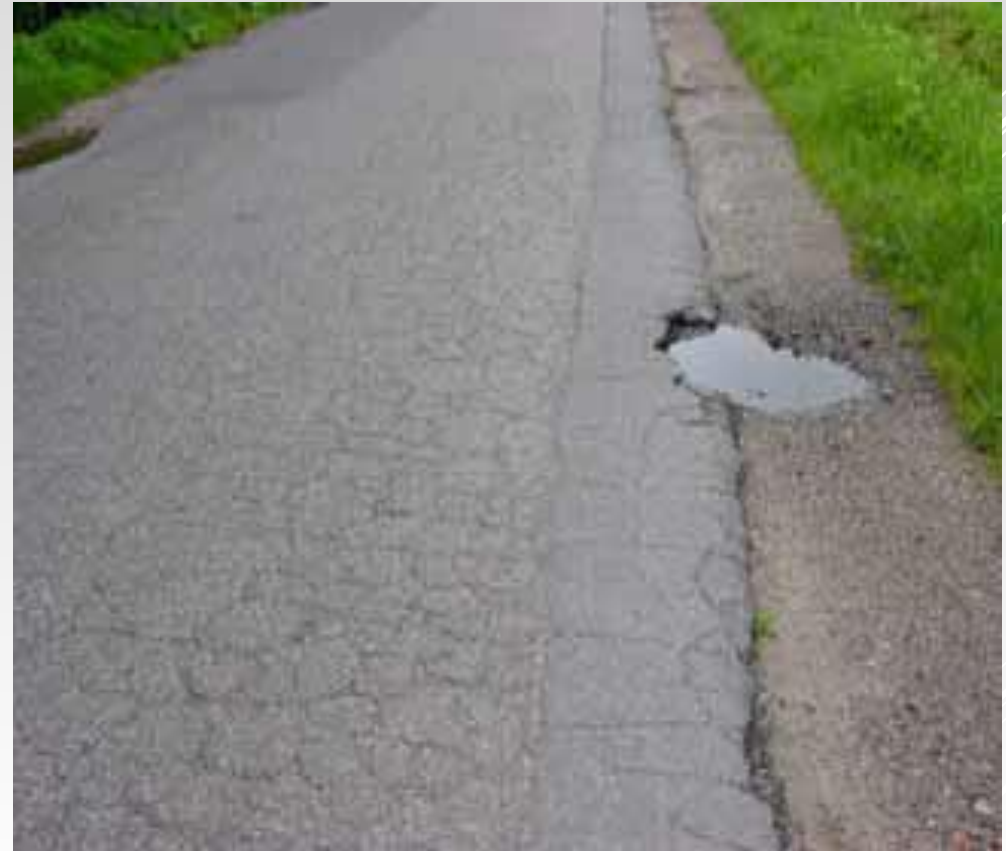
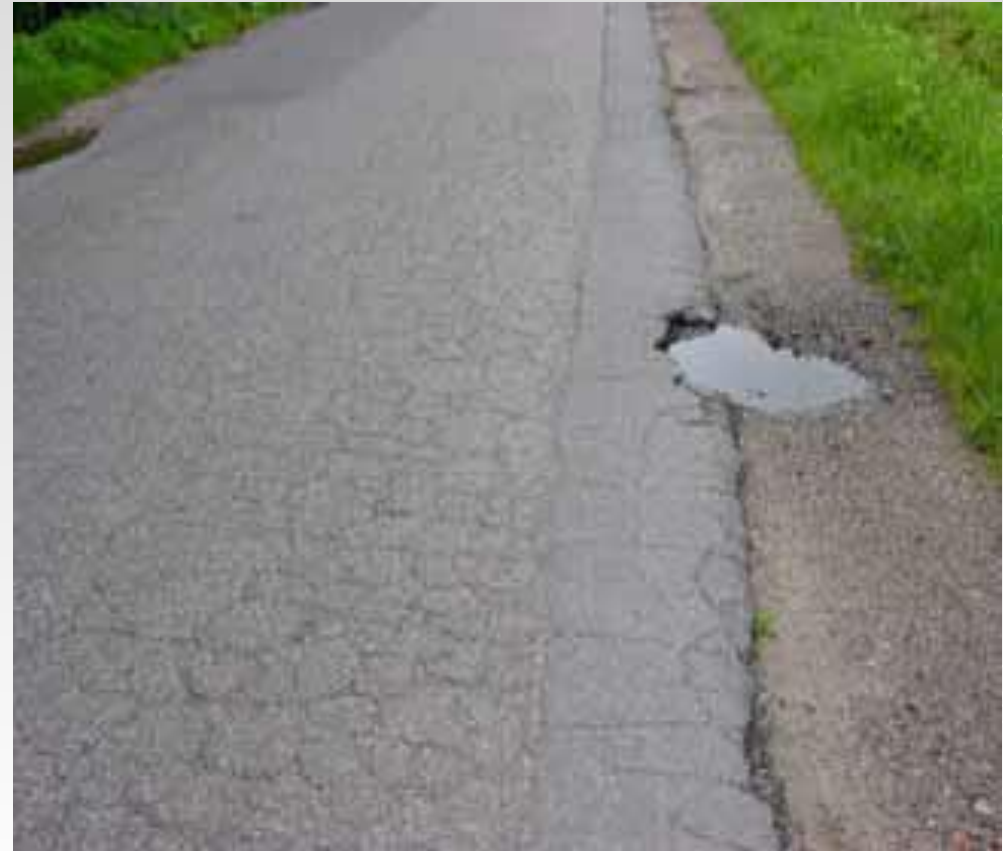
Figure 3 is a picture of a cracked surface of a rather narrow pavement. If vehicles have to pass each other, the outer wheels have to travel through the verge. From the edge, damage that is observed one can conclude that this is regularly the case. The base material, which is visible in the verge, seems to be a stiff and hard material. This is an indication that some kind of slag that shows self-cementing properties was used as base material.

*Figure 3: Cracking observed on a narrow polder road in the Netherlands.*

Further indications of the fact that such a base material has been used can be found from the fact that the pavement surface is smooth; no rutting is observed. The extensive cracking of the pavement surface might be a combination of shrinkage cracks that have developed in the base. It is however also very well possible that the adhesion between the asphalt layer and the base is rather poor. If this is the case then high tensile strains will develop at the bottom of the asphalt layer causing this layer to crack.

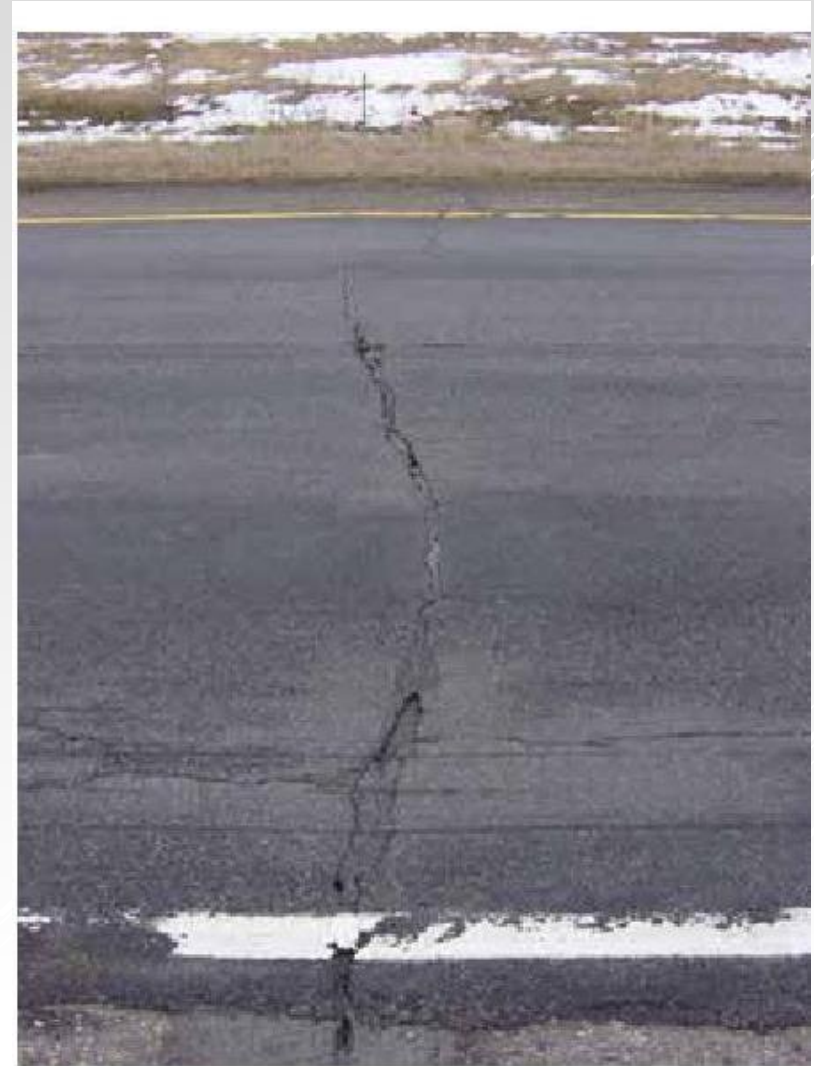
Figure 4 is a typical example of low temperature cracking. In areas with cold winters, this type of cracking is quite often the dominating cracking type. Due to the very cold weather, the asphalt concrete wants to shrink. In principle this is not possible and tensile stresses develop as a result of the drop in temperature. The magnitude of the tensile stress depends on the rate of cooling and the type of asphalt mixture; especially the rheological properties of the bituminous binder are of importance. If the tensile stresses are becoming too high, the pavement will crack at its weakest point. Further cooling down of the pavement results in additional cracking and existing cracks will open. It is obvious that crack spacing and crack width are interrelated. A large crack spacing results in wide cracks and vice versa. Low temperature cracking can be the result of a single cooling down cycle but also can be the result of repeated cooling down cycles (low temperature fatigue)

*Figure 4: Low temperature cracking observed on a highway in Minnesota.*

However, when heavy wheel loads are passing a crack like the one shown in figure 4, high tensile stresses will develop at the crack edge simply because of the fact that there is no load transfer. This problem might increase during the spring when moisture enters the crack and weakens the supporting layers. All this means that although traffic associated cracking is not the main problem, traffic can cause accelerated damage development near cracks.

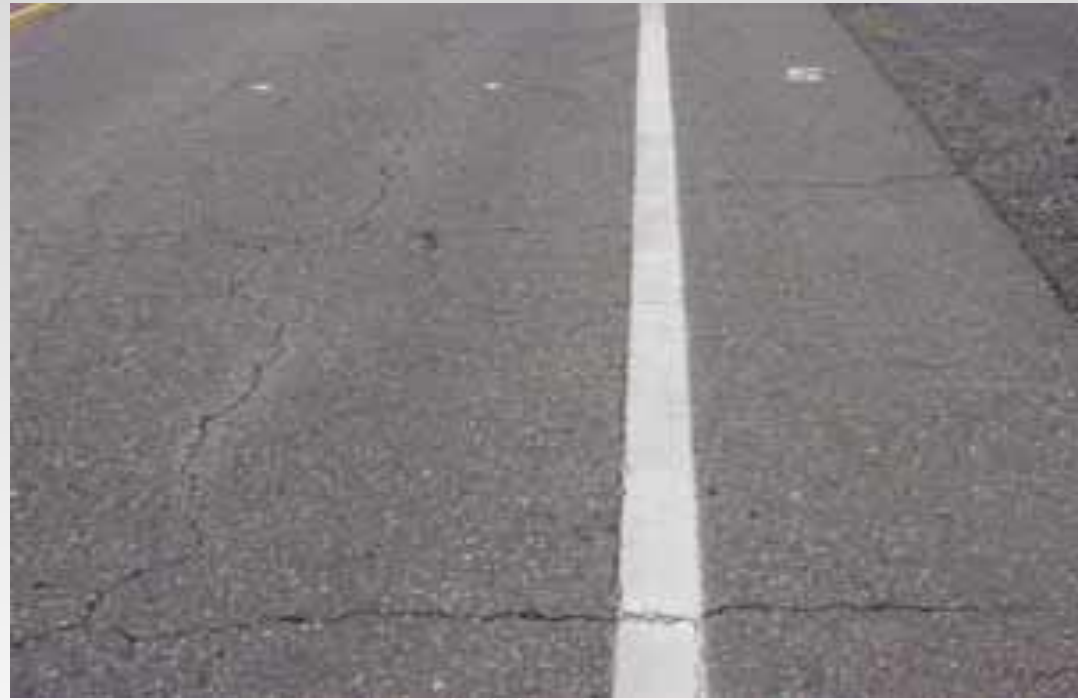
Figure 5 is an example of temperature related block cracking. The pavement of course not only shrinks in the longitudinal direction but also in the transversal direction. In that case the friction between the asphalt layer and the base is of importance. If that is high, high tensile stresses might occur in the transversal direction causing longitudinal cracks. Combined with the crack pattern shown in figure 4, this results in block cracking. As mentioned before, low temperature cracking can be the major cause of maintenance and traffic associated cracking is only of secondary importance in such cases.

*Figure 5: Low temperature associated block cracking observed on a highway in Minnesota.*

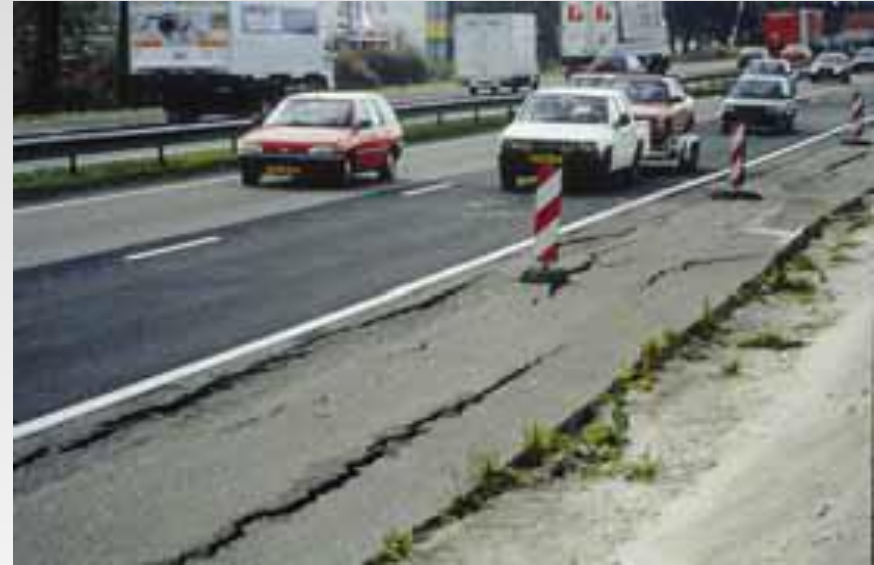
Of course cracks can develop for many other reasons than traffic and environmental effects. One example of such “another reason” is given in figure 7 which shows severe cracking in the emergency lane due to the widening of the embankment next to that lane. Due to the widening, excessive shear stresses developed in the existing embankment resulting in the development of a shear plane leading to severe longitudinal cracking not only in the emergency lane but also in the slow lane (this lane is already repaired as the picture shows). The problem was aggravated by the fact that a significant height difference occurred across the longitudinal crack resulting in very dangerous driving conditions for motor cyclists. This type of cracking is clearly due to a soil mechanics problem and therefore is beyond the scope of these lecture notes.

Figure 7: Severe longitudinal cracking due to shear failure in the existing embankment as a result of widening the road (extended embankment is on the right hand side).

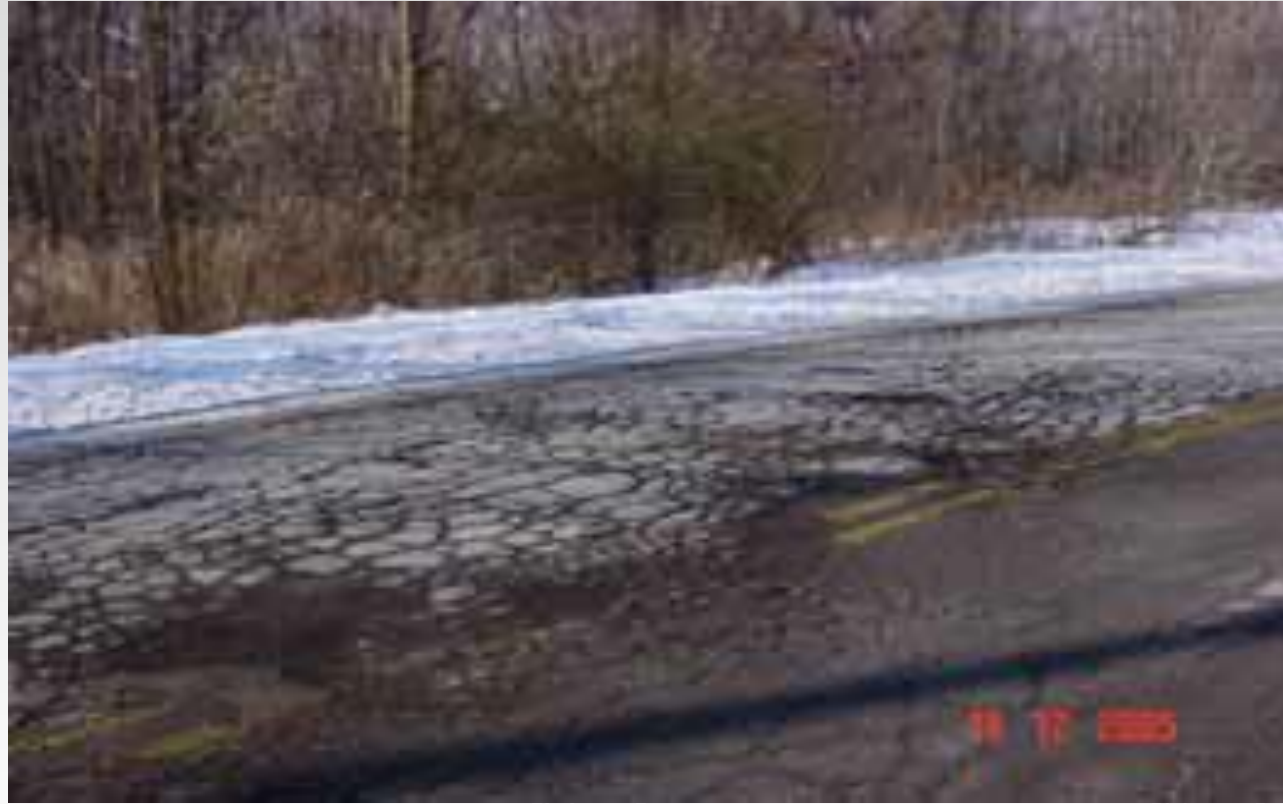
Figure 8 shows a severely cracked farm to market road in Ohio. Due to the extensive amount of cracking, the pavement has become rather rough. It is quite clear from the picture that cracking has not only resulted in longitudinal but also transverse deformations. It is a typical example of medium wavelength roughness.

Figure 8: Roughness due to severe cracking.

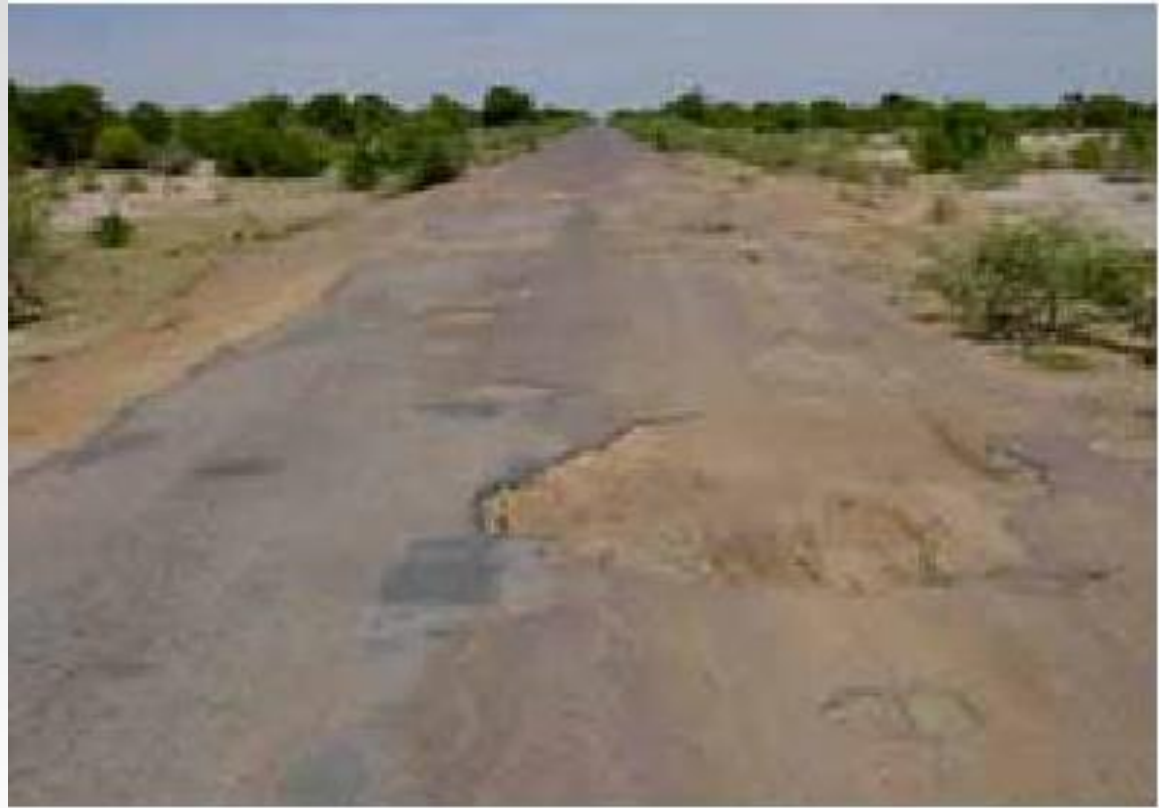
Figure 9 shows a pavement in Zimbabwe. Lack of maintenance has resulted in potholes which obviously result in a large decrease of driving comfort. Even dangerous situations might occur when driving at night. The reason for the potholes is that pavement has cracked severely, comparable to a condition shown in figure 8, and at given moment small pieces of the surface layer have been driven out. Erosion of the potholes due to rain and wind results in depressions of significant size and depth.

Figure 9: Roughness due to potholes as a result of severe cracking.

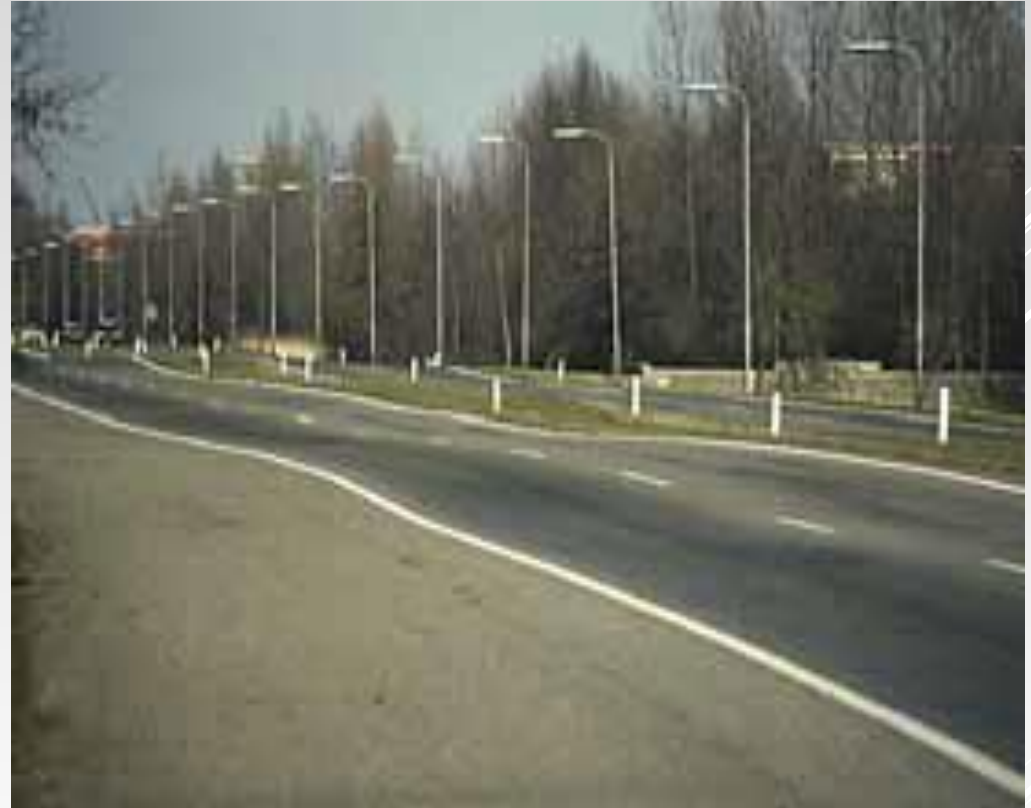
Figure 10 was taken on a provincial road close to the Delft University in the Netherlands. The long wave longitudinal unevenness that can be observed is clearly the result of settlements. Please note that the settlements also have caused deformations in the transverse direction.

Figure 10: Longitudinal deformations due to settlements.

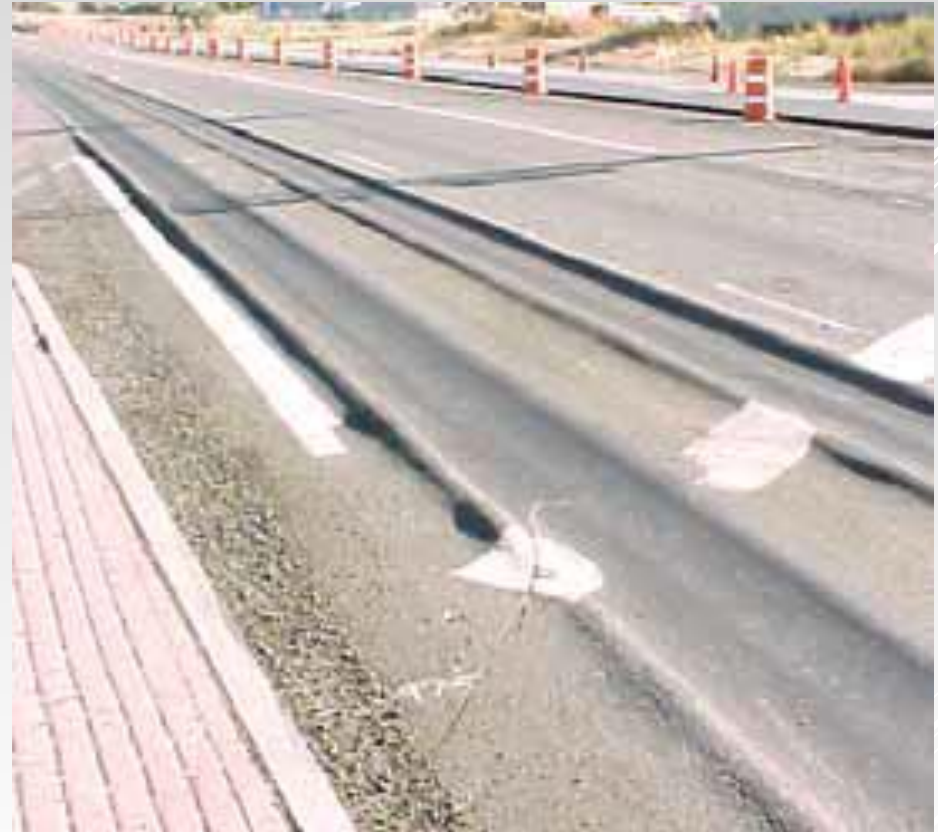
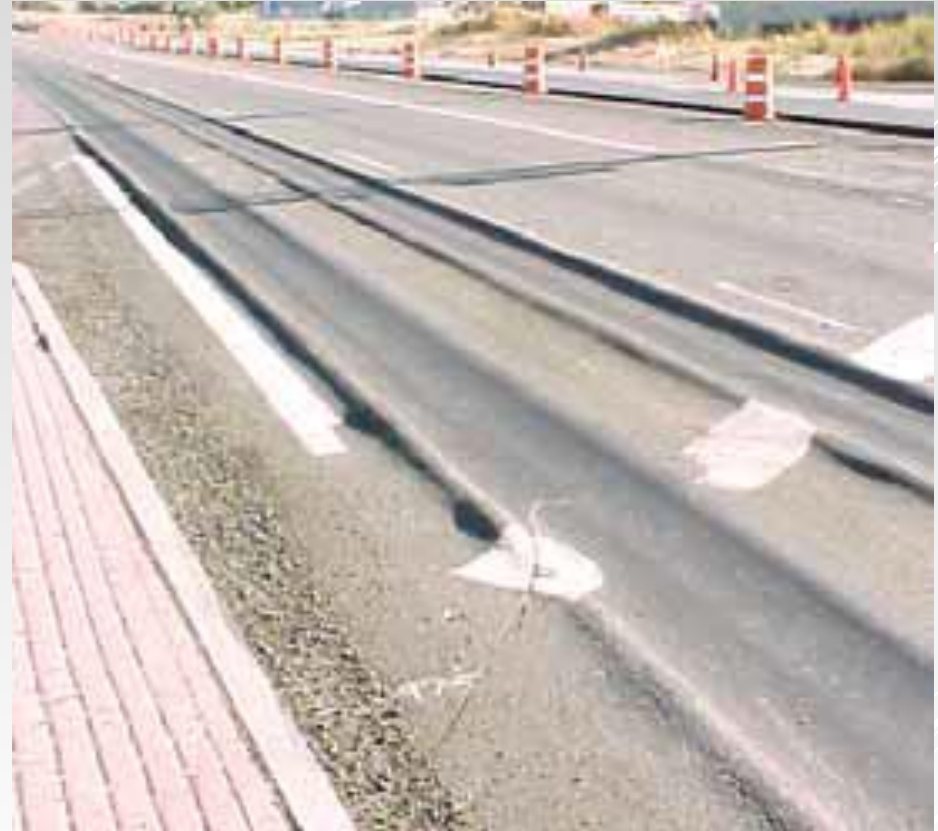
The best known transversal deformation type due to traffic is rutting or permanent deformation that occurs in the wheel paths. A typical example of rutting is shown in figure 11.

Figure 11: Rutting in an asphalt pavement.

- Rutting can develop in the asphalt layer(s) or in the unbound base, subbase or subgrade.
- Rutting can be the result of a densification process or as a result of shear failure. The rutting shown in figure 11 is clearly caused by shear failure in the asphalt layer. Shear failure can be recognized by the ridges that have developed next to the depression.

Furthermore, one can state that the narrower the depression the higher the layer is located in the structure where the shear failure has developed. The same is true for corrugations or washboard formation that is quite often observed near traffic lights or on unsurfaced roads.

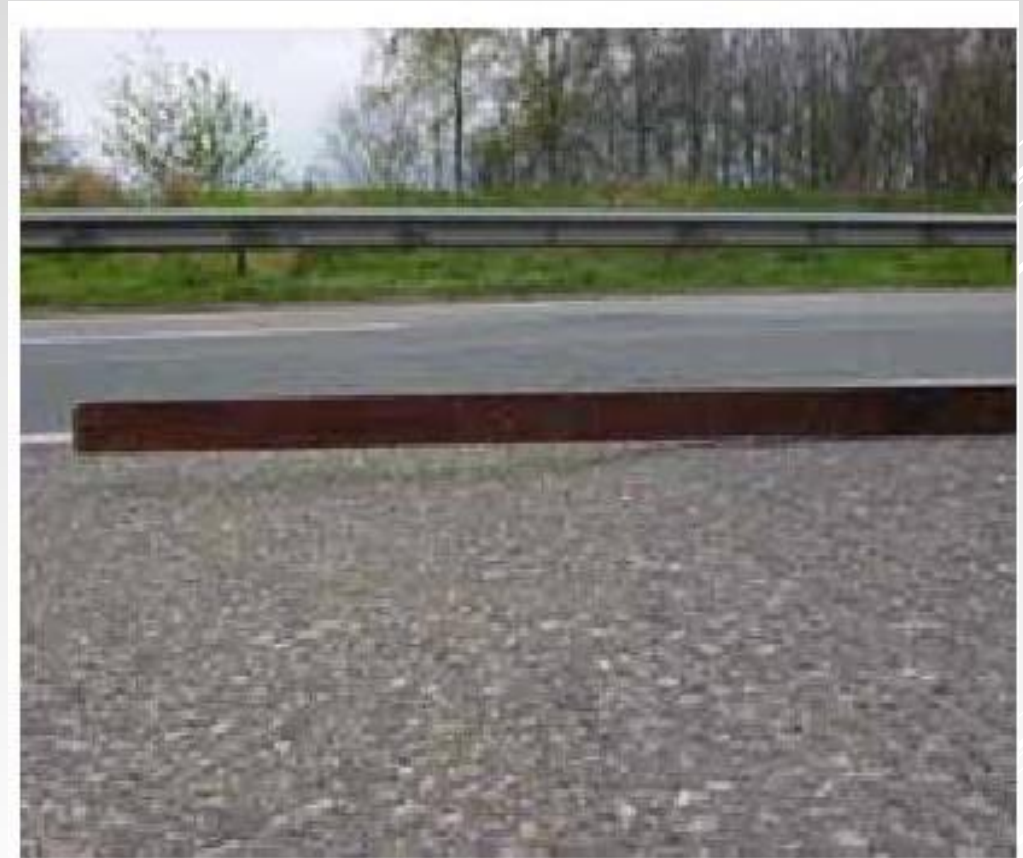
Figure 12 shows a type of longitudinal unevenness that is quite often observed on pavements with a base course made of blast furnace slags. Because of the chemical reactions that take place, the material wants to expand resulting into compressive stresses that at a given moment become higher than the compressive strength of the material. Buckling of the base course is then the result leading to ridges which negatively influence driving comfort and which might have a negative effect on traffic safety because of loss of cargo from trucks

Figure 12: Unevenness due to "buckling" of the base made of blast furnace slag.

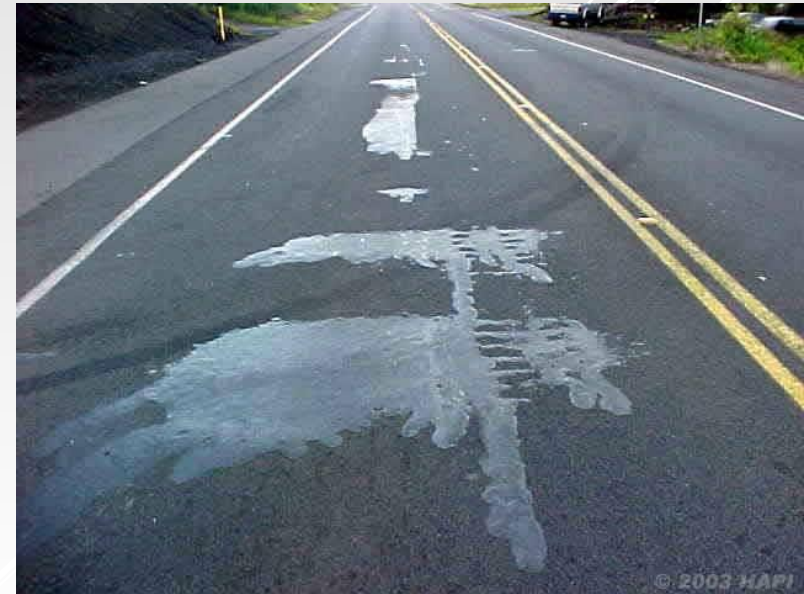
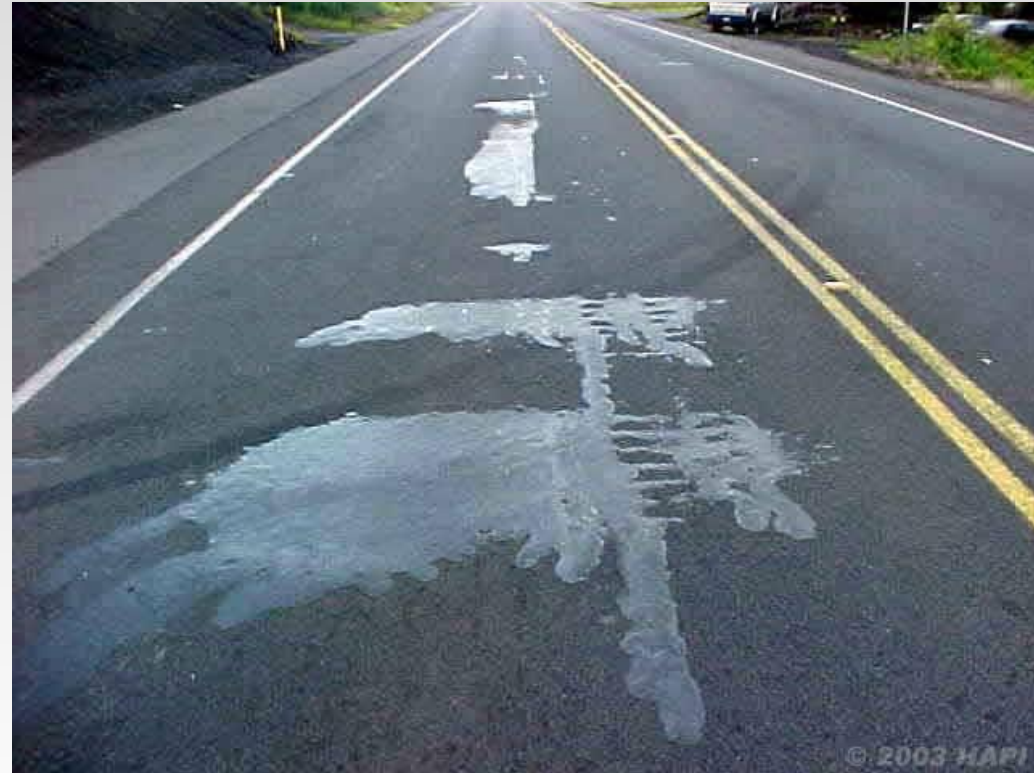
- Bleeding is a defect type that can be recognized as black, “fatty” looking spots on the pavement surface.
- It is an indication of overfilling of the voids in the aggregate skeleton with bituminous mortar.
- It is an indication that the mixture is not well designed.

Due to the high bitumen content, the mixture suffers probably from lack of stability at higher temperatures and high traffic loads might squeeze out the bituminous mortar.

Another reason might be that because of the low void content, there is not enough space for the bituminous mortar when it expands with increasing temperatures.

In any case, the result is the same being a black, shiny surface with hardly any macro or micro texture and thus a low skid resistance.
