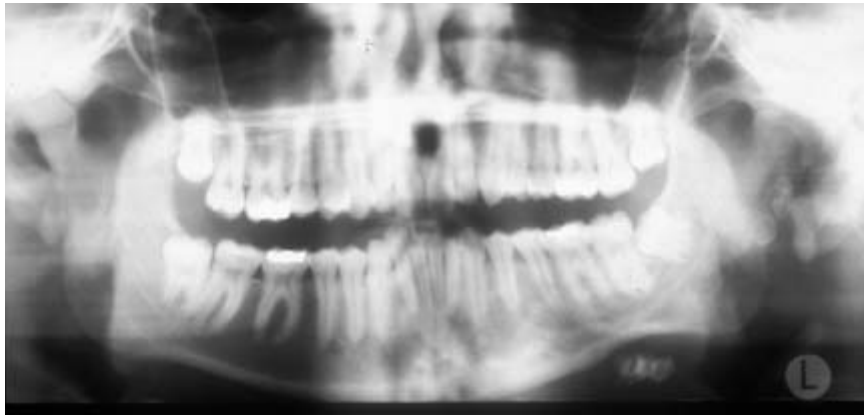
**Figure 5.8a.** A panoramic radiograph demonstrating calcifications within the left submandibular region.

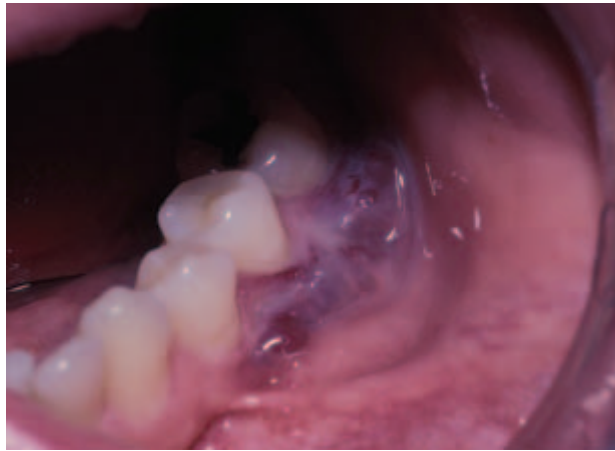
**Figure 5.8b.** At first glance of the radiograph, submandibular sialolithiasis is a reasonable consideration. Close examination of the radiograph reveals multicentric lamellated calcifications in the submandibular and preauricular regions, as well as a calcification superimposed on the left mandibular second molar roots. A complete physical examination revealed signs consistent with a hemangioma associated with the left mandibular gingiva. As such, the calcifications are presumed to represent phleboliths, and are not removed. It is important, therefore, to diagnose sialolithiasis based on a review of a radiograph as well as a physical examination.
